**A REPORT ON THE VIRGINIA TRANSPORTATION RESEARCH COUNCIL'S  
TECHNICAL DELEGATION TO THE CZECH REPUBLIC**

**AUGUST 16–23, 2002**

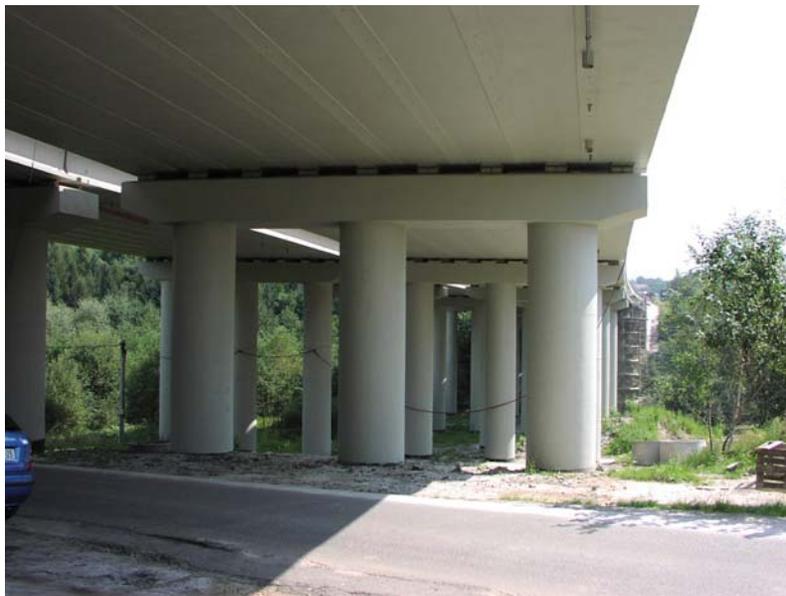
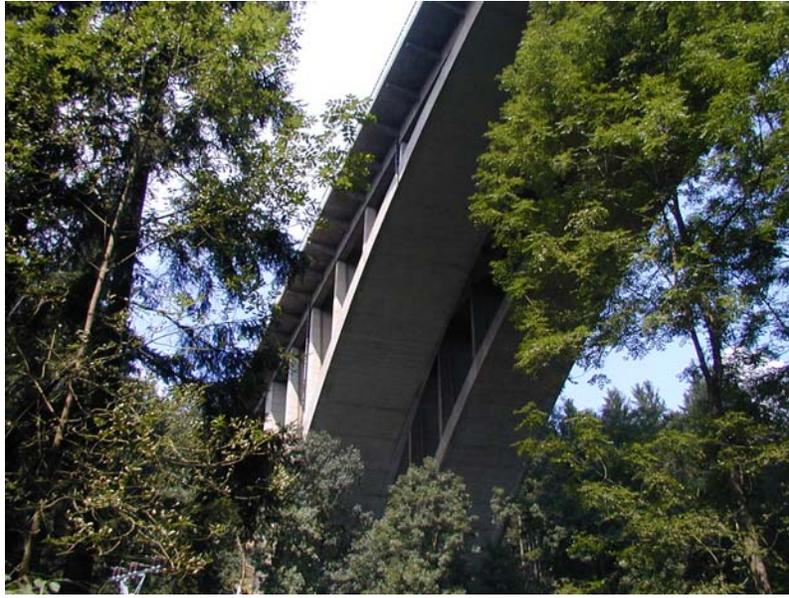
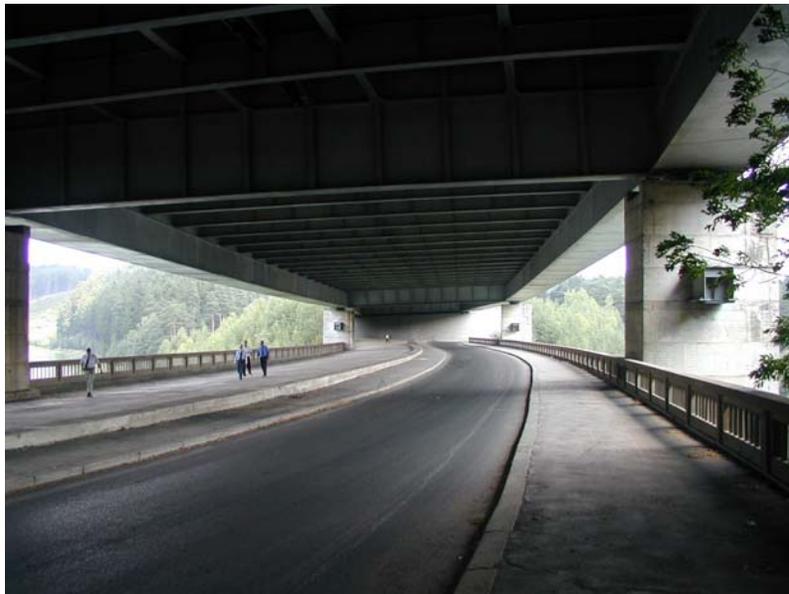
a number of field visits to concrete structures, both constructed and under construction. Figures 2 through 4 depict a few of the structures visited. The lower bridge in Figure 4 was constructed prior to World War II and survived intact. With the realignment of the motorway, a new bridge was constructed on top using the same substructure.

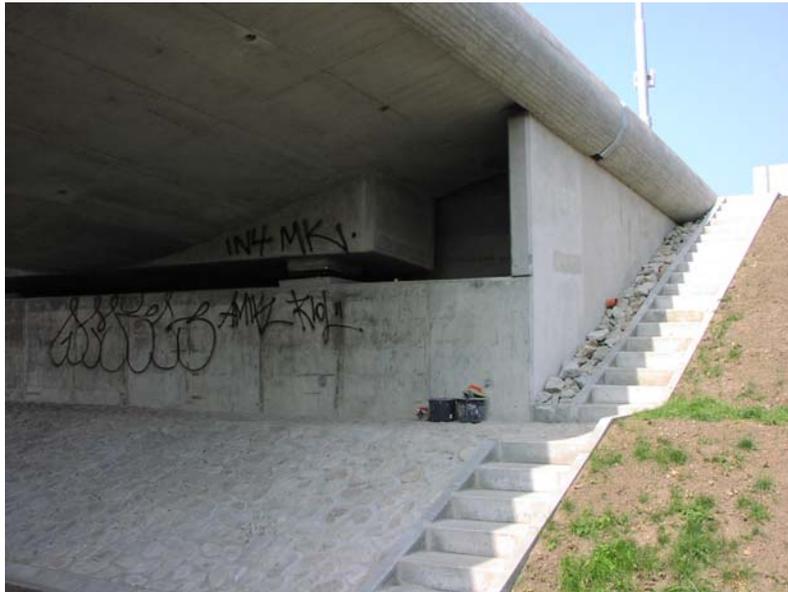
**Figure 5. Stairs Along the Abutments**

We noticed stairs along the abutments to facilitate maintenance and inspections as shown in Figure 5.

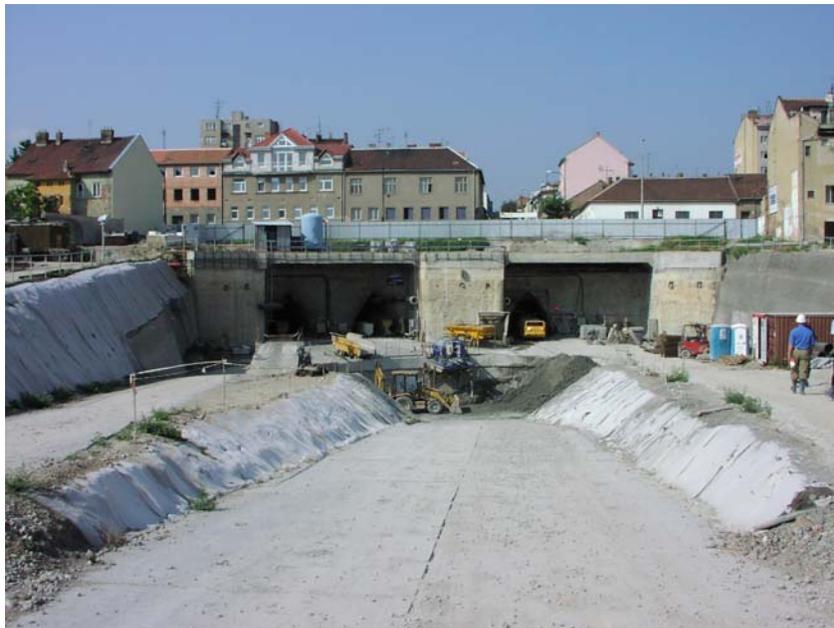
**Figure 7. Tunnel Construction**

Dr. Ozyildirim and Mr. Sprinkel visited a tunnel being built under existing buildings as shown in Figure 7.

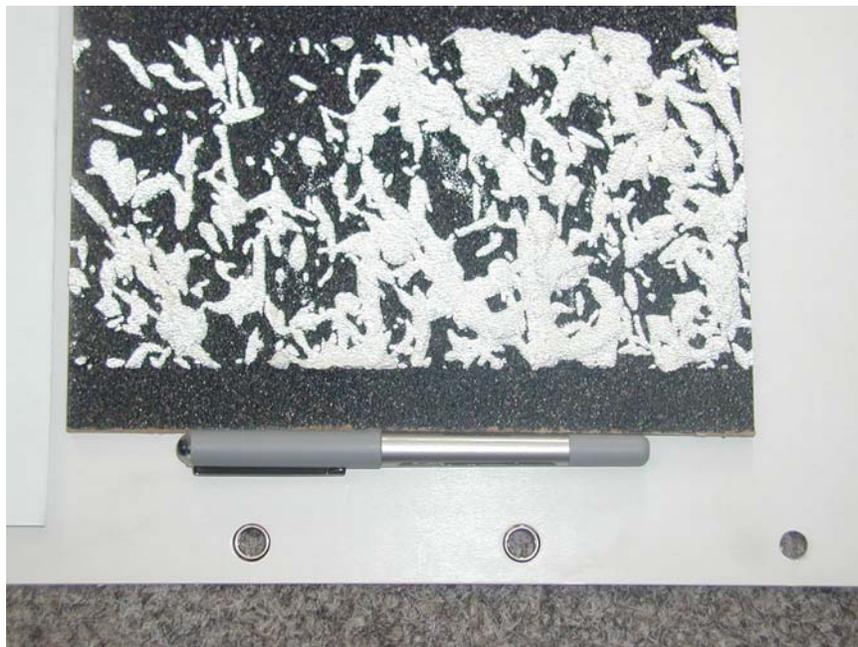
A short discussion on wet reflective pavement markings occurred. It appears that the Czech Republic uses structured or patterned pavement markings to provide wet reflectivity. In fact, these officials stated that structured or patterned materials are the only markings that are retroreflective when wet conditions exist. They also do not feel that the current European wet test method will work with paint or thermoplastic products. This is even true for materials with large glass beads. In fact, their comment was that “nothing works when the material is flooded.” Figure 8A and B show the two types of materials used for wet reflectivity.

**Figure 8A. Wet Reflective Patterned Material**

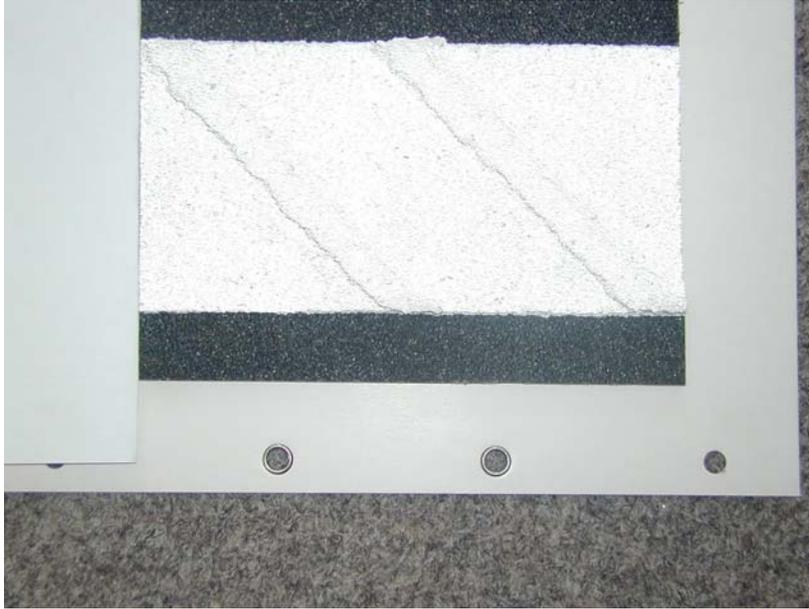
**Figure 8B. Wet Reflective Structured Material**

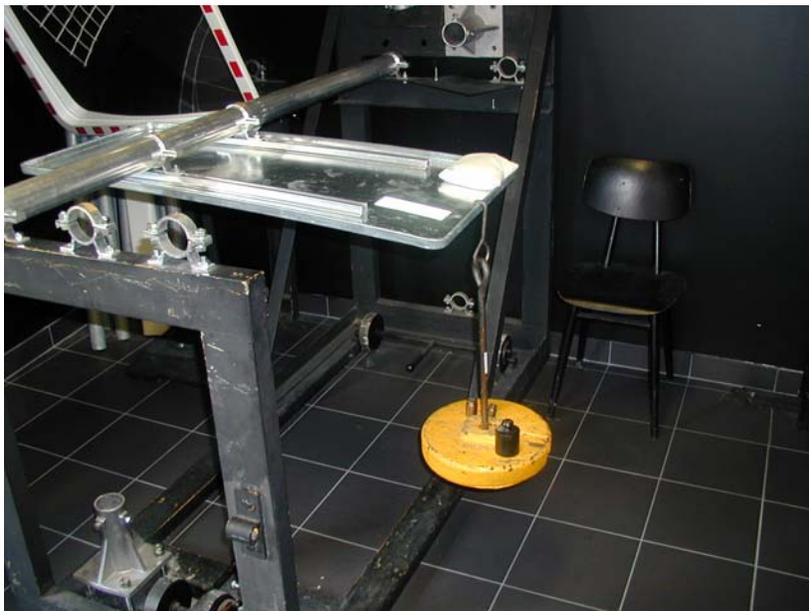
One other item discussed was the type of sign substrate being used in the Czech Republic. Because of high levels of aluminum sign theft, the government changed the specifications to require a less expensive material (not aluminum). Unfortunately, the exact substrate was not known, but it was thought to be an iron-zinc compound. Figure 9 shows the testing equipment used to determine suitability of the substrate.

**Figure 9. Sign Substrate Testing Equipment**

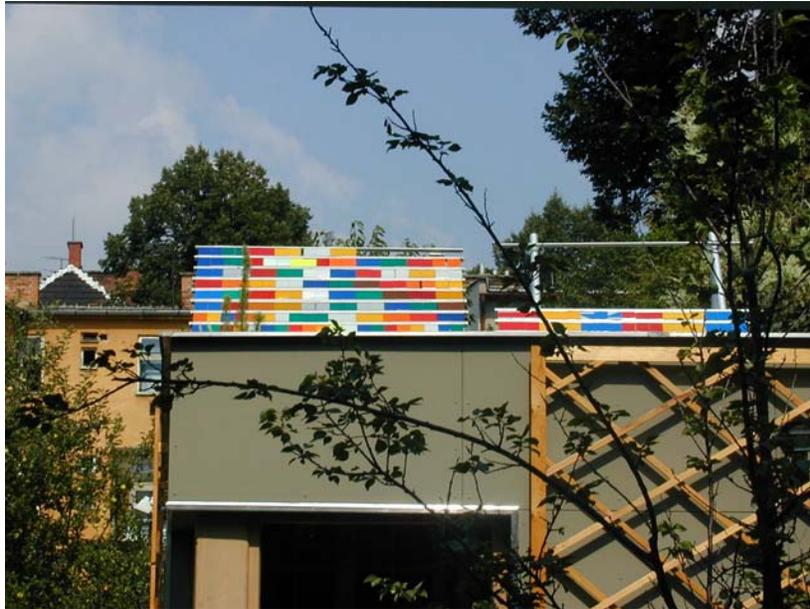
Figure 10 shows this company's site for the exposure testing of sign sheeting materials.

**Figure 10. Exposure Testing of Sign Sheeting Materials**

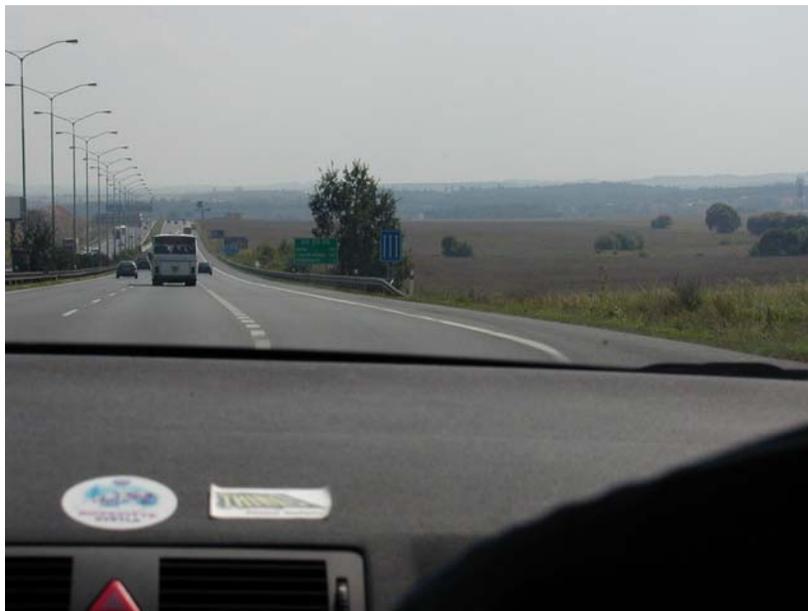
It was noted on the travel from Prague to Brno that the guardrail end treatments appeared similar to the “suicide” run-on sections that were prominent on roadways in the United States in the late 1960s through the early 1980s. Figure 11 depicts the typical run-on sections found on the Czech motorways. The CDV indicated that they had not conducted any research on guardrail related accidents or severity. It was noted that significant research has been undertaken in the United States to improve the crashworthiness of guardrail and some of this information would be forwarded to the CDV for their consideration.

**Figure 11. Typical Guardrail Run-On End Sections**

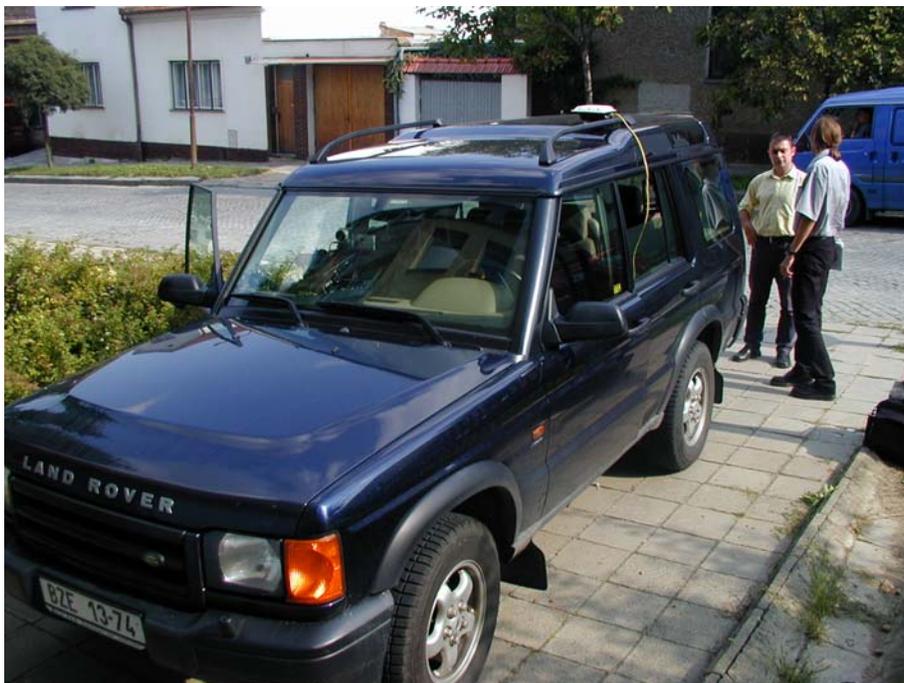
The CDV has invested in an instrumented vehicle for safety and ITS-related research. Figures 12 through 14 show the vehicle and some of its amenities. The vehicle is outfitted with a 12-channel GPS receiver, two digital video cameras (one front, one rear), a distance-measuring instrument (DMI), and infrared sensors, all of which are linked directly to a notebook computer.

**Figure 12. Instrumented Data Collection Vehicle**

With the digital cameras and the software developed, the vehicle is able to determine the headways of vehicles around it while in the traffic stream. The infrared sensors on both sides of the vehicle can capture a passing vehicle's speed and record this in real time on the computer.

The vehicle can also be used to collect an inventory of a roadway's assets (i.e., signs, signals, and markings). The digital camera in the front of the vehicle records the asset, and the computer operator codes the image in the database. Since the vehicle is outfitted with a GPS, the system automatically provides latitude and longitude coordinates based on the location of the asset. The system is able to perform this since the camera's field of view is calibrated prior to each run. The capabilities of the field inventory system would be an asset to a department of transportation attempting a sign inventory program.

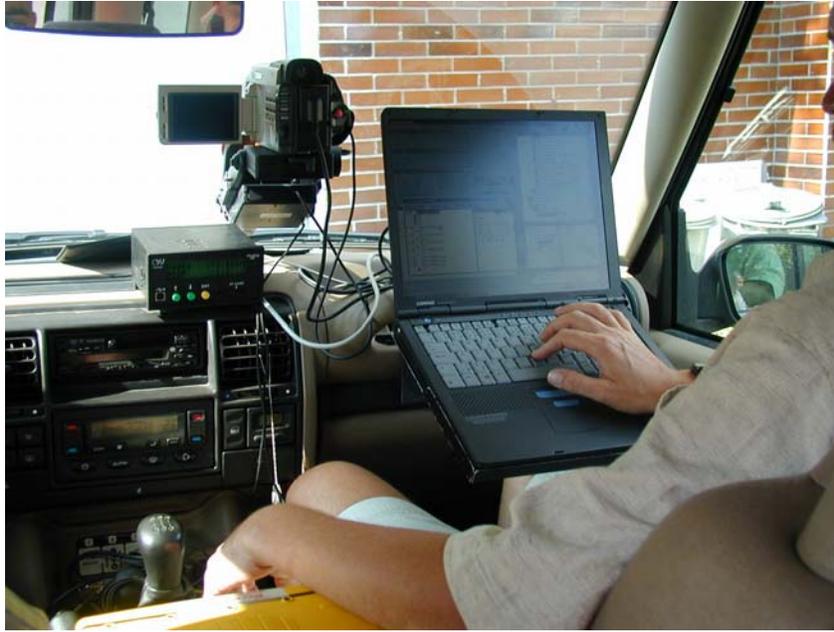
**Figure 13. Digital Camera, DMI, and Notebook Computer**

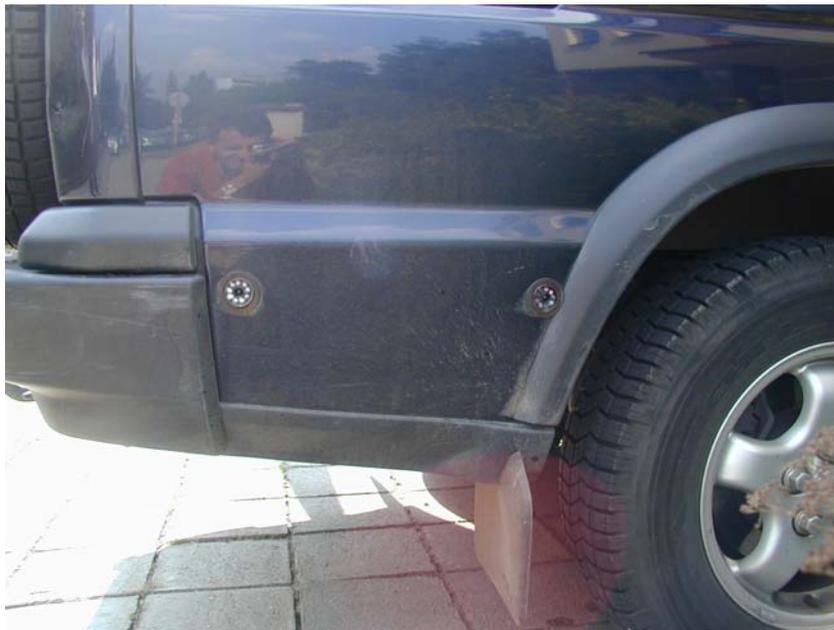
**Figure 14. Infrared Sensors**

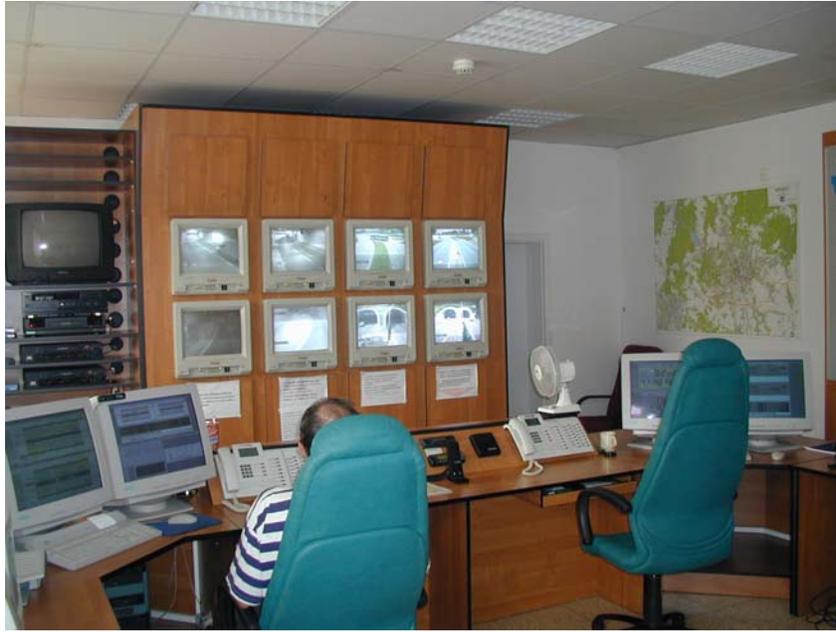
The control center monitors two tunnels and 85 signals throughout Brno (Figure 15). The tunnel system monitors traffic via cameras inside and outside the tunnel. The cameras inside are fixed (zoom only), and the outside cameras have pan/tilt/zoom capabilities. Traffic speed and volume are monitored via inducted loops placed before the entrance. A computer system also monitors the environmental systems of the tunnel (air conditioning, ventilation, and lighting).

**Figure 15. Tunnel and Signal System Control Center**

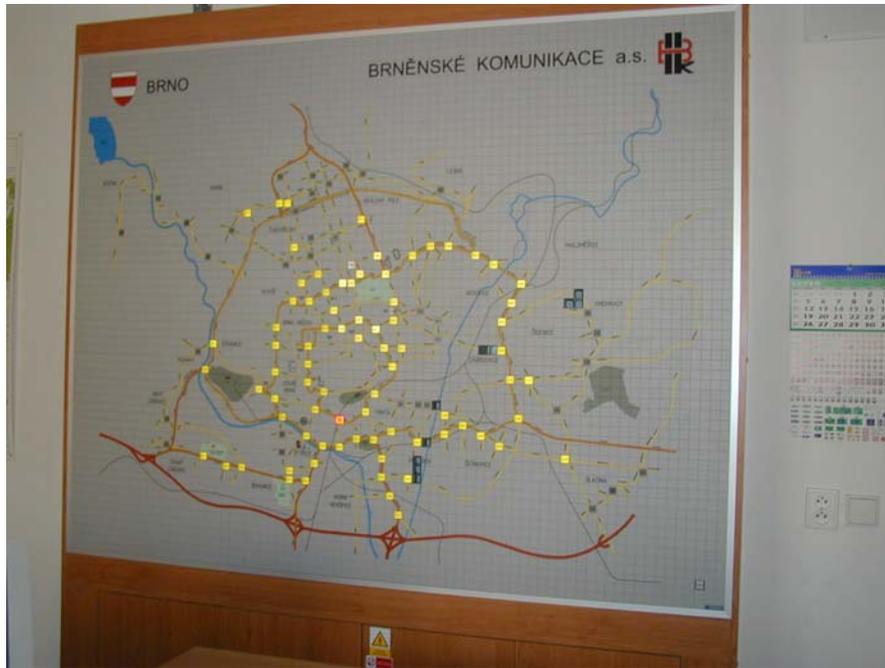
Figure 16 shows the monitoring wall for the 85 signals. The signals are only monitored since the communication corporation is responsible for only the maintenance of these systems and not for their operation. It was interesting to learn that the police are responsible for the day-to-day operations of the signals. Most signals are actuated and have timing plans in place based on time of day and day of week. Timing plans are developed at the communication corporation and then sent to the Police Department to implement. (From an observation viewpoint, this process appears to require twice the number of people to perform the same function.)

**Figure 16. Signal System Health Monitoring Wall**

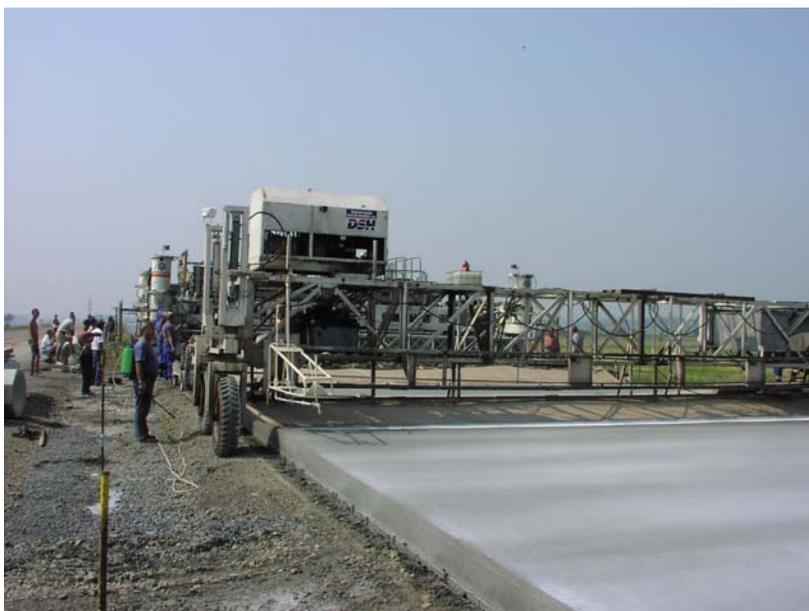
During the tour, we were fortunate to watch a typical paving operation. Figure 17 shows the use of a two-stage construction technique. That is, in the same paver, two sections provide the two layers: a higher quality concrete over a base concrete. Thus, the wearing surface is made with a very high-quality concrete and is expected to provide long service. The paver inserted plastic coated dowels automatically. A curing compound is sprayed after the concrete is textured.

**Figure 17. Pouring of Concrete Slab**

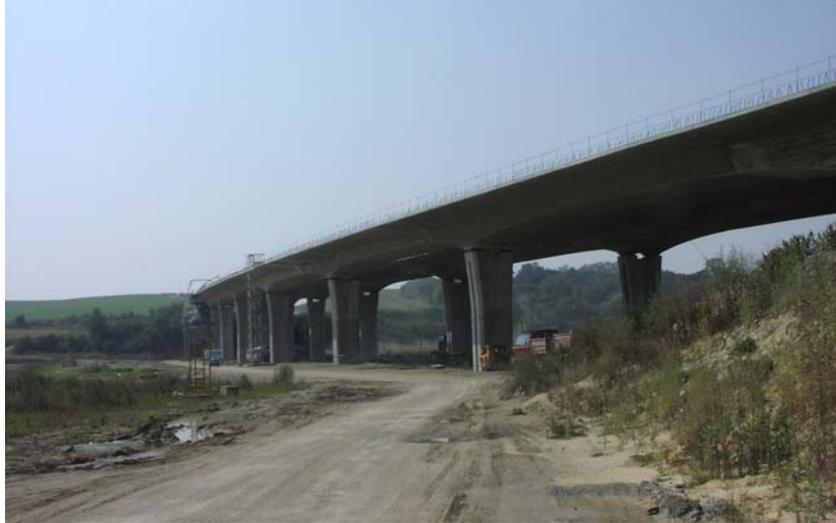
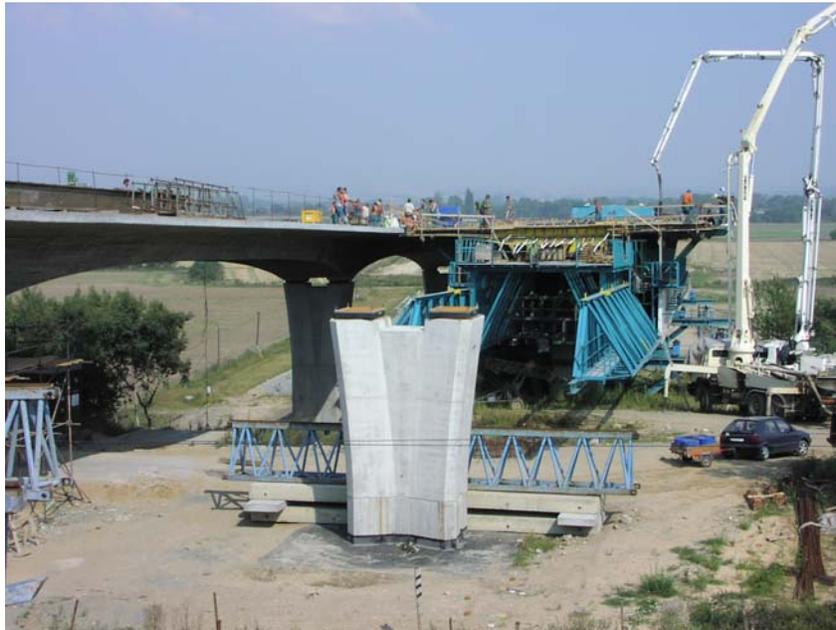
The group was also taken to a bridge construction site. The bridge depicted in Figures 18 and 19 show a Norwegian technology that enabled the construction of a span in 12 days. Using normal procedures the time to construct the span would have been 1 month. Thus, speed of construction is an issue and can be achieved using new technologies. As with other bridges throughout the Czech Republic, the bridge decks on this project will have an asphalt overlay.

**Figure 18. Bridge Over Railroad**

**Figure 19. Construction Activities of Structure**
