3.5 Belgium

* Concrete Pavements in Belgium

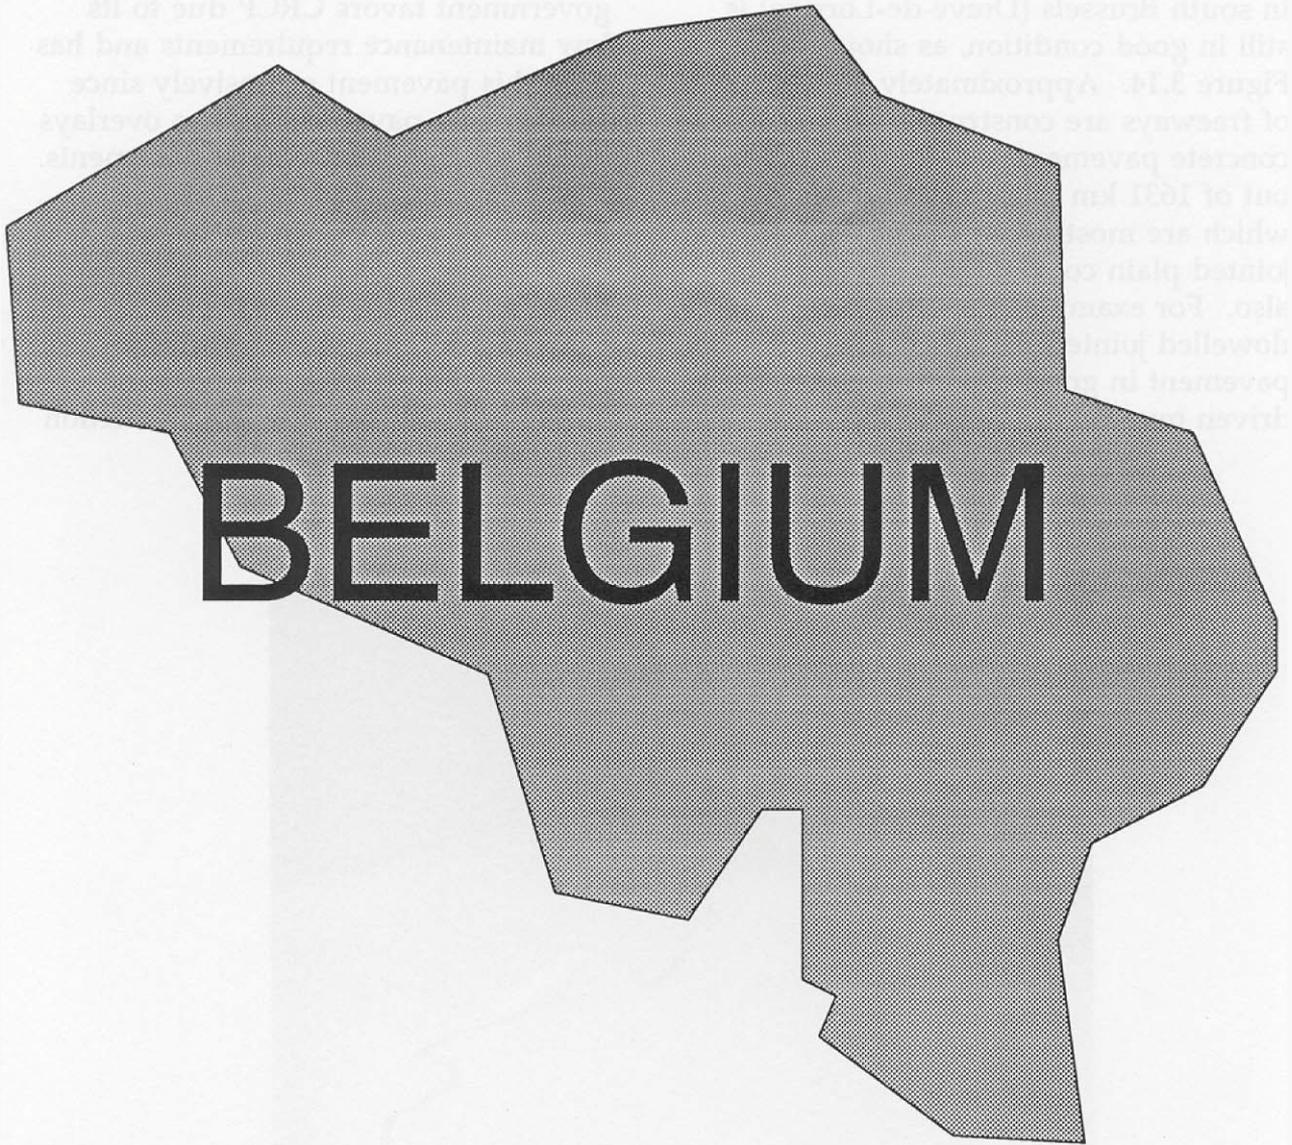
Figure 3.14 Dreve-de-Lorraine highway, Brussels, a 67-year-old jointed concrete pavement constructed in 1925 with no longitudinal joints.

Belgium has constructed concrete for many years. A 67-year-old jointed concrete pavement constructed in 1925 in south Brussels (Dreve-de-Lorraine) is still in good condition, as shown in Figure 3.14. Approximately 40 percent of freeways are constructed with concrete pavement (645 km (400 miles) out of 1631 km (1023 miles) total) which are mostly CRCP, but a lot of jointed plain concrete pavement exists also. For example, a 35-year-old dowelled jointed plain concrete pavement in good condition was driven over on the freeway between

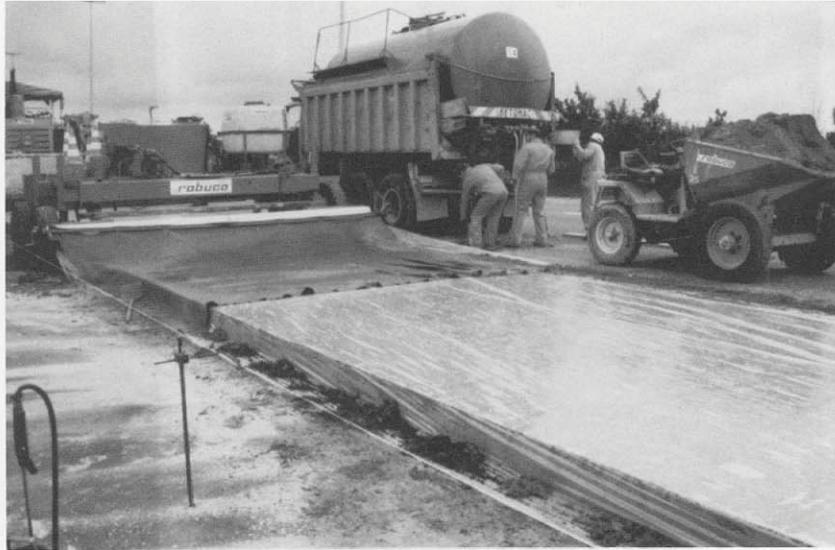
Figure 3.16 Polyethylene sheeting placed over concrete surface after retarder has been sprayed (Robuco process). (4)

✓ The low-noise surface texture was produced by chemically exposed aggregate. The slab is placed in one layer (the steel was placed on chairs) with the same aggregate throughout its depth (2 cm (0.8 in) maximum size). After the paver passes, the surface is immediately sprayed with a retarder which penetrates several millimeters into the mortar. A polyethylene sheet is then placed over the surface as shown in Figure 3.16. This serves to protect the retarder from the effects of inclement weather and to provide for curing when the retarded surface mortar is removed through special wire brushing after 24 to 72 hours.

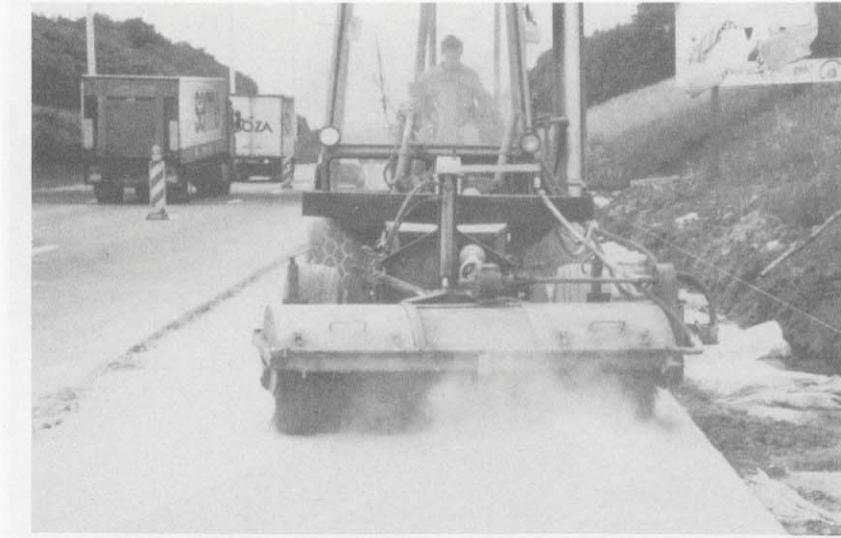
Figure 3.17 Rotary brush removing thin surface layer of mortar to provide the exposed aggregate surface after polyethylene sheeting has been removed.

The surface aggregate is exposed to achieve the desired texture using a rotating brush shown in Figure 3.17. Either a sugar-based retarder which provides a 2 mm (0.8 in) texture (used on the E40 project), or a chemical retarder which provides a finer 1 mm (0.4 in) texture (as used in Austria) may be used. (4)
